# Fever Control at a Preschool

## ~ Hoshino Hikari Preschool ~

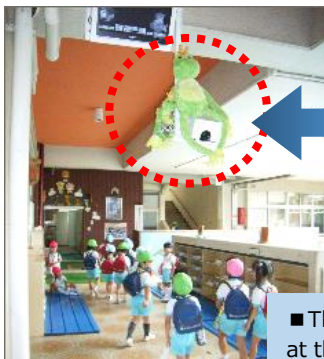
■ Thermography installed at the entrance (Froggy)

Thermography is installed in a position where toddlers must pass everyday. It automatically measure body surface temperature when toddlers say hello to the froggy on top of it.

Thermal image is displayed to monitors at administration office and health room, where teachers check. When a toddler is found over 37.0℃, alarm sound is generated so that teachers can identify and take care of them.

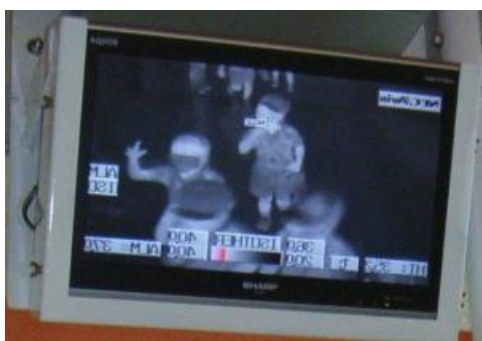
When a fever is recognized.  
(Image)

Heated area over 37°C is displayed in **red color**.  
Alarm sound is generated simultaneously.
